Manhole Inspection Summary

Manhole # S3700_011MH

Insp Date: **1/29/07 12:23 PM**

Location Address: **2239 HOMEWOOD AVE**

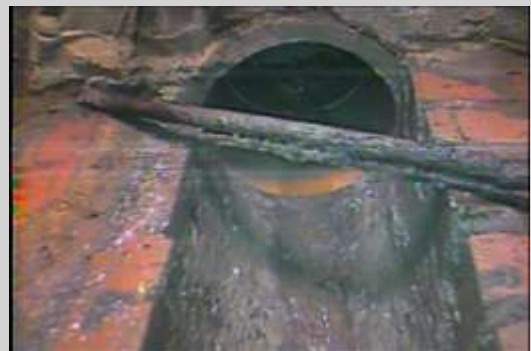
Drop In @ 6 O'Clock

Drop: **Outside** Rod and Bar
Angled: **Yes** Reading: **6.78** (ft.)
Inv Depth: **7.78** (ft.)

Drop Condition: **Open**
